SELECTIVE SOLDER TROUBLESHOOTING GUIDE

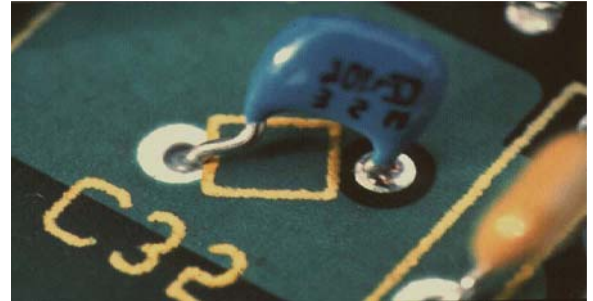
PROBLEM: INSUFFICIENT HOLE FILL

- Not enough flux
- Distance from Fluxer to PCB is too high, Flux can not go up the hole
- Pin to hole ratio is too small
- Temperature on top side of board is too low
- Solder temperature is too low
- Distance from solder wave to PCB is too high

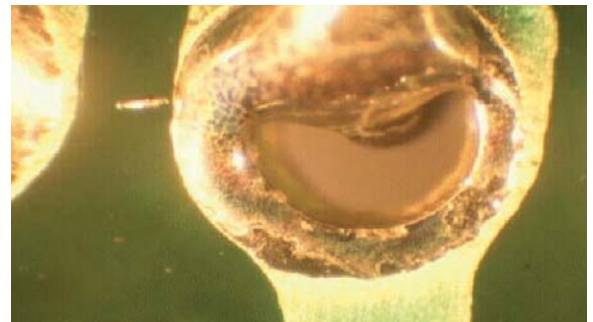
PROBLEM: INSUFFICIENT SOLDER

- Not enough flux
- Solderability of component
- Bad PCB pads
- Solder time too short, reduce speed or increase dipping
- Distance from solder wave to PCB is too high
- Bad flux solids

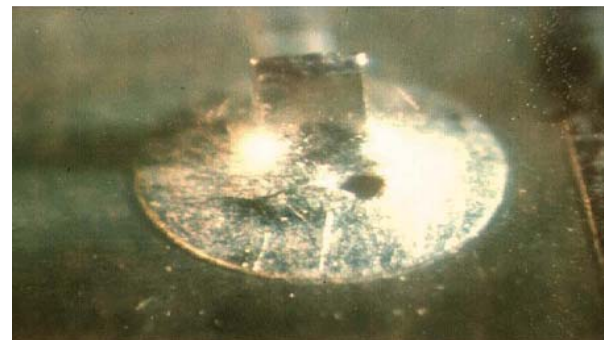
PROBLEM: BLOW HOLES

- Board temperature is too low
- Moisture in the PCB

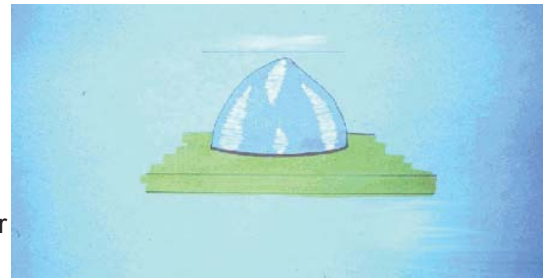
PROBLEM: EXCESSIVE SOLDER

- Typically happens at the end of line soldering of connectors
- Layout too tight to make a good peel off movement
- Try to move over the connector or diagonally out of the connector
- Let the wave switch off at the end of the connector
- Board / Component solderability
- Lead length is too long (1 to 1.5mm is perfect)
- Solder temperature is too low
- Speed is too fast, solder time is too short

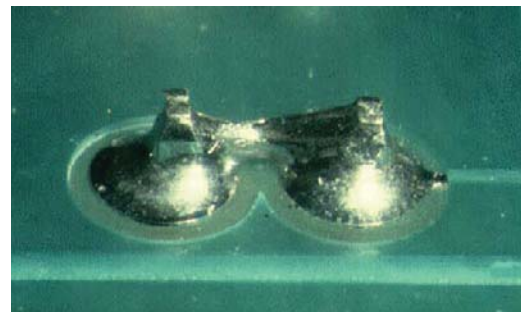
PROBLEM: BRIDGING

- Typically happens at the end of line soldering of connectors
- If bridging occurs in the middle or at the beginning of a connector, it is typically a heat or N2 purity problem
- Layout is too tight to SMD component to make a good peel off movement
- Let the wave switch off at the end of the connector
- Board / Component solderability
- Lead length is too long (1 to 1.5mm is perfect)
- Solder temperature is too low
- Speed is too fast, solder time is too short

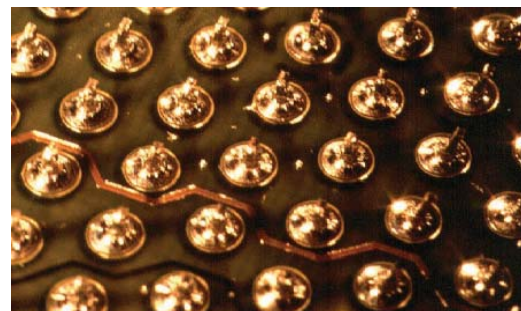
PROBLEM: SOLDER BALLS

- Occur more often in selective soldering than in wave soldering. Reason is typically due to the higher temperatures used in selective soldering
- Solder mask type is the most important factor
- Too much flux
- N2 adjustment is too high
- Preheat is too low

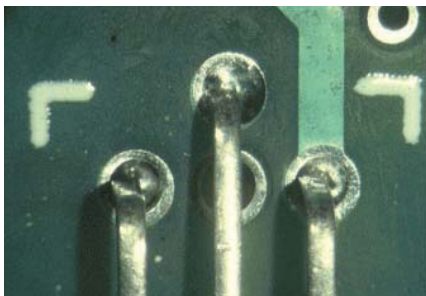
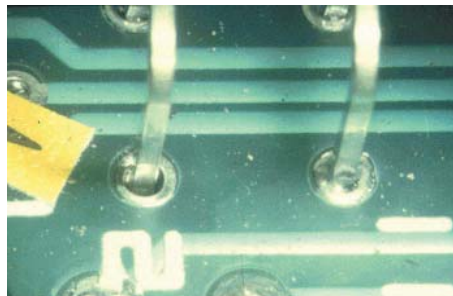
PROBLEM: POOR HOLE FILLING

Poor or incomplete hole fill is normally a fluxing or heating issue. It is not commonly a printed board problem.

As a guide, the topside temperature of the printed board should be 100° - 110°C just before wave contact. This is generally true for double sided and multilayer boards. Single sided boards should be processed at slightly lower temperatures as no solder penetration is needed.

In the above examples, the solder has not fully filled the plated thru-hole. This is either due to the preheat operation being set too low or poor flux application. In both cases, checking the process parameters should eliminate the problem.

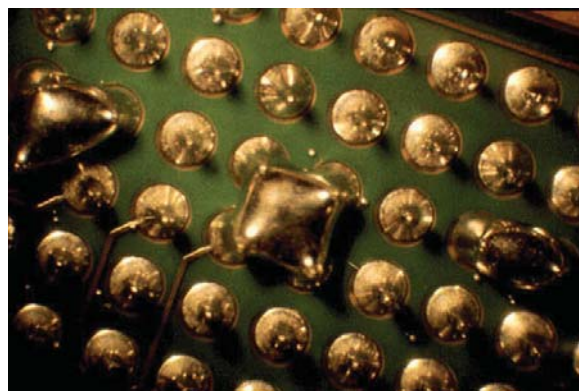
PROBLEM: SOLDER SHORTS ON PIN GRID ARRAY

Solder shorts are a major problem in both selective and wave soldering, particularly as component pitches continue to decrease.

In the example shown, shorts are seen on the Pin Grid Array device. Due to the close proximity and the number of pins, the solder separation is impeded from the base of the board. Shorting can occur due to poor fluxing, incorrect heat or wave separation. Poor N2 quality can also cause shorts.

All shorting can be decreased through good design rules with reduction in pad size and component lead length. A lead length from 1 - 1.5mm is perfect for selective soldering. Longer pins can cause more shorts.

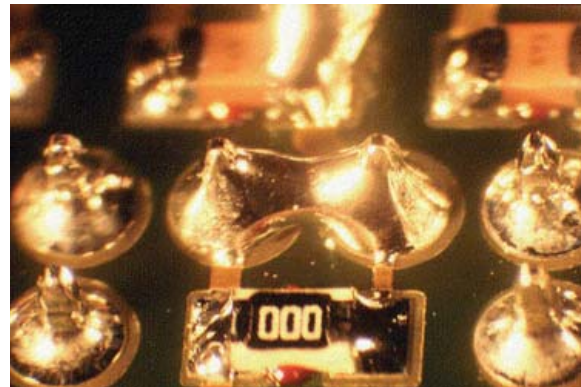
PROBLEM: SOLDER SHORTS NEAR SMD COMPONENTS

It is critical to selective solder a heavily populated board. Most can only be fluxed by good design. Increasing the flux solids will improve the drainage on all joints.

In the example shown, the pin length is correct at 1 - 1.5mm, but the surface pads could be reduced in size. With smaller pads, less solder is retained on the board to short between pins.

If this is the only defect area on the board, then a nice fix is a glue dot placed between the two pins.

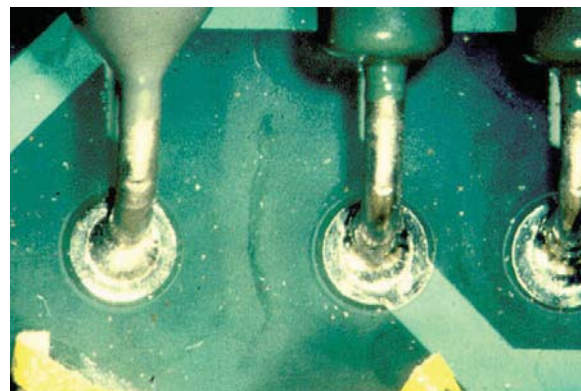
PROBLEM: SUNKEN SOLDER JOINTS

Sunken joints may be seen on the topside and base of the board.

The most common cause for sunken joints is the hole to lead ratio. If the hole is large in comparison to the lead diameter, the solder literally drops in or out of the hole.

Sunken solder joints can be caused by incorrect preheat or poor fluxing when seen on the topside of the board.

Sunken solder joints on the base of the board may be caused by outgassing. If the soldering process is functioning correctly, when the hole outgasses the solder tends to shrink back into the hole to fill the void.
