SELECTIVE SOLDER TROUBLESHOOTING GUIDE (cont.)

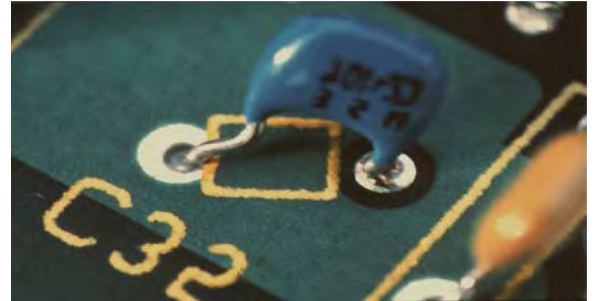
PROBLEM: INSUFFICIENT HOLE FILL

- Not enough flux
- Distance from Fluxer to PCB is too high, Flux can not go up the hole
- Pin to hole ratio is too small
- Temperature on top side of board is too low
- Solder temperature is too low
- Distance from solder wave to PCB is too high

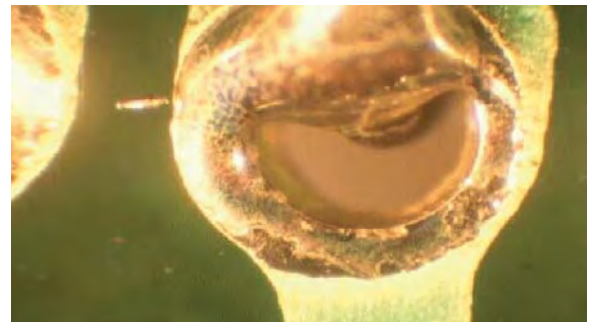
PROBLEM: INSUFFICIENT SOLDER

- Not enough flux
- Solderability of component
- Bad PCB pads
- Solder time too short, reduce speed or increase dipping
- Distance from solder wave to PCB is too high
- Bad flux solids

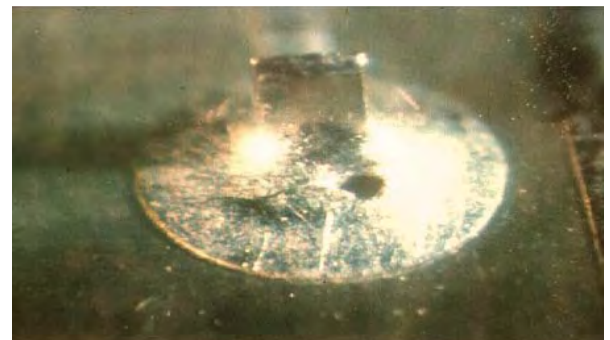
PROBLEM: BLOW HOLES

- Board temperature is too low
- Moisture in the PCB

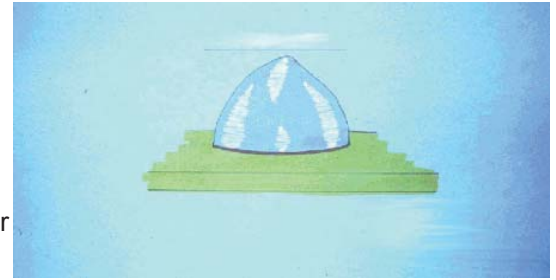
PROBLEM: EXCESSIVE SOLDER

- Typically happens at the end of line soldering of connectors
- Layout too tight to make a good peel off movement
- Try to move over the connector or diagonally out of the connector
- Let the wave switch off at the end of the connector
- Board / Component solderability
- Lead length is too long (1 to 1.5mm is perfect)
- Solder temperature is too low
- Speed is too fast, solder time is too short

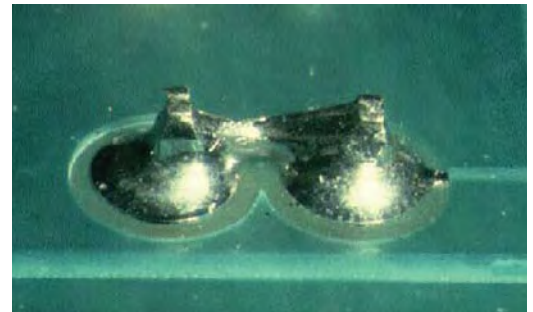
PROBLEM: BRIDGING

- Typically happens at the end of line soldering of connectors
- If bridging occurs in the middle or at the beginning of a connector, it is typically a heat or N2 purity problem
- Layout is too tight to SMD component to make a good peel off movement
- Let the wave switch off at the end of the connector
- Board / Component solderability
- Lead length is too long (1 to 1.5mm is perfect)
- Solder temperature is too low
- Speed is too fast, solder time is too short

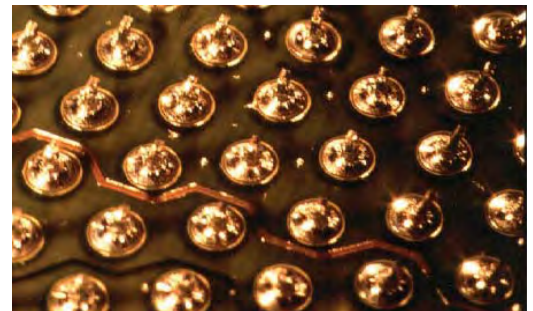
PROBLEM: SOLDER BALLS

- Occur more often in selective soldering than in wave soldering. Reason is typically due to the higher temperatures used in selective soldering
- Solder mask type is the most important factor
- Too much flux
- N2 adjustment is too high
- Preheat is too low

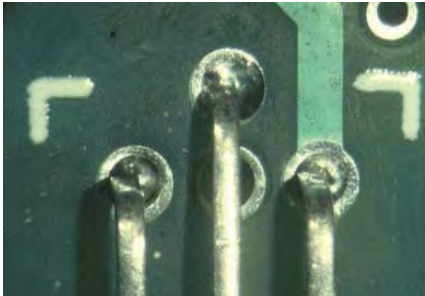
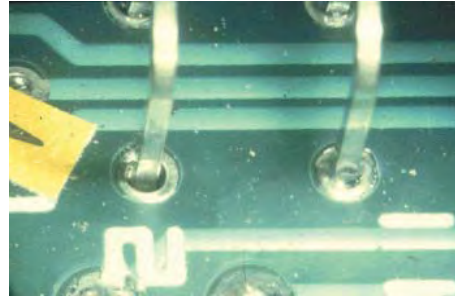
PROBLEM: POOR HOLE FILLING

Poor or incomplete hole fill is normally a fluxing or heating issue. It is not commonly a printed board problem.

As a guide, the topside temperature of the printed board should be 100° - 110°C just before wave solder contact. This is generally true for double sided and multilayer boards. Single sided boards should be processed at slightly lower temperatures as no solder penetration is needed.

In the above examples, the solder has not fully filled the plated thru-hole. This is either due to the preheat operation being set too low or poor flux application. In both cases, checking the process parameters should eliminate the problem.

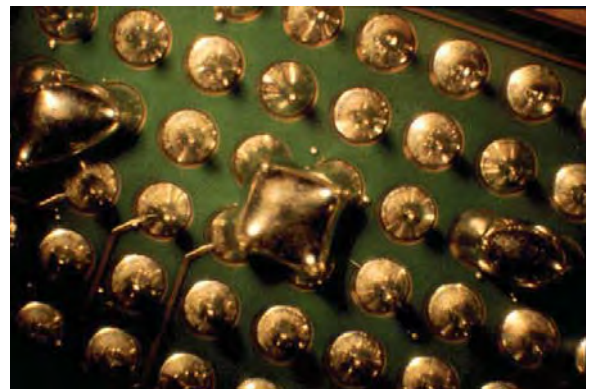
PROBLEM: SOLDER SHORTS ON PIN GRID ARRAY

Solder shorts are a major problem in both selective and wave soldering, particularly as component pitches continue to decrease.

In the example shown, shorts are seen on the Pin Grid Array device. Due to the close proximity and the number of pins, the solder separation is impeded from the base of the board. Shorting can occur due to poor fluxing, incorrect heat or wave separation. Poor N2 quality can also cause shorts.

All shorting can be decreased through good design rules with reduction in pad size and component lead length. A lead length from 1 - 1.5mm is perfect for selective soldering. Longer pins can cause more shorts.

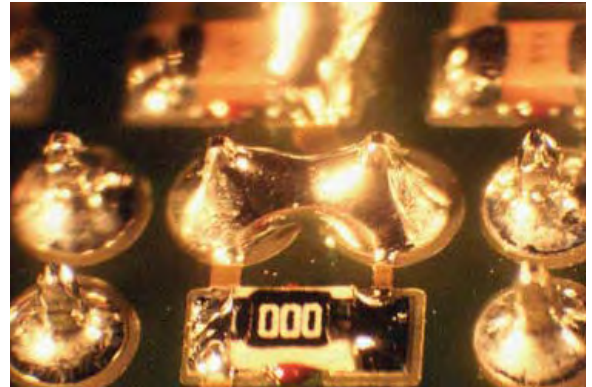
PROBLEM: SOLDER SHORTS NEAR SMD COMPONENTS

It is critical to selective solder a heavily populated board. Most can only be fluxed by good design. Increasing the flux solids will improve the drainage on all joints.

In the example shown, the pin length is correct at 1 - 1.5mm, but the surface pads could be reduced in size. With smaller pads, less solder is retained on the board to short between pins.

If this is the only defect area on the board, then a nice fix is a glue dot placed between the two pins.

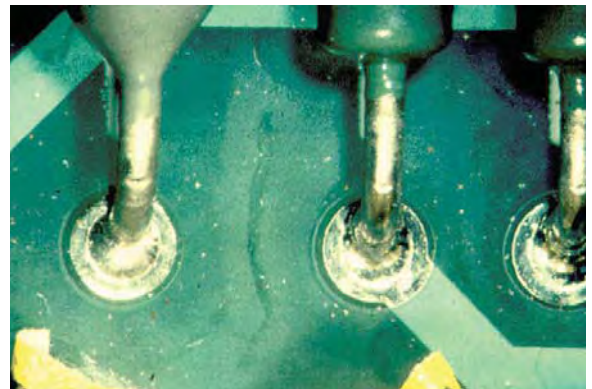
PROBLEM: SUNKEN SOLDER JOINTS

Sunken joints may be seen on the topside and base of the board.

The most common cause for sunken joints is the hole to lead ratio. If the hole is large in comparison to the lead diameter, the solder literally drops in or out of the hole.

Sunken solder joints can be caused by incorrect preheat or poor fluxing when seen on the topside of the board.

Sunken solder joints on the base of the board may be caused by outgassing. If the soldering process is functioning correctly, when the hole outgasses the solder tends to shrink back into the hole to fill the void.
